**PINE CREEK WATERSHED  
CHANNEL and RIPARIAN ASSESSMENT  
and  
RESTORATION PLAN**

**NORTH AREA ENVIRONMENTAL COUNCIL**  
in partnership with the  
**PINE CREEK WATERSHED COALITION**

**ALLEGHENY COUNTY, PENNSYLVANIA**

**March 2010**

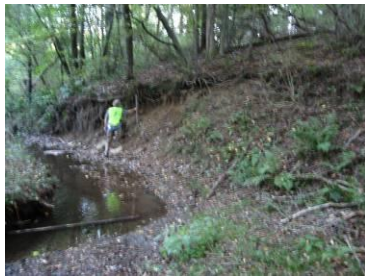
Erosion on a scour bank at a bend in the stream destabilizes a steep bank.

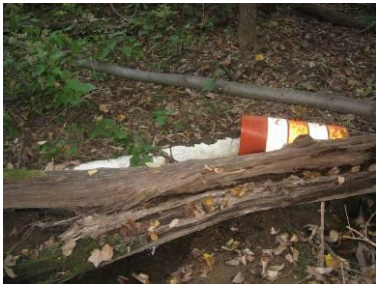
Could this have been moved by a storm? Dumping affects stream and riparian quality.

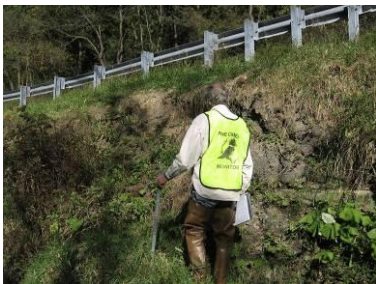
Streambank erosion along roadways can result in roadbed collapse...an expensive infrastructure repair.

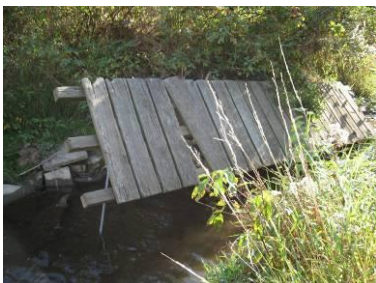
Improperly and illegally constructed bridges and streamside structures can wash away and block streams, increasing flood damage.

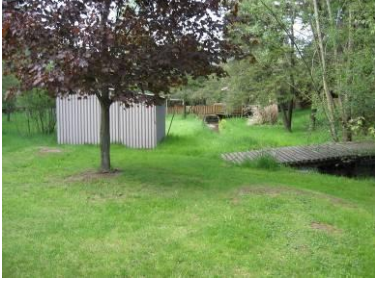
Streamside structures and bridges can create stream blockages during high water events.

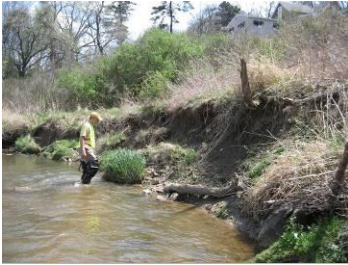
A number of places along MP3 have severe bank erosion. In this area the erosion could eventually impact the properties above it.

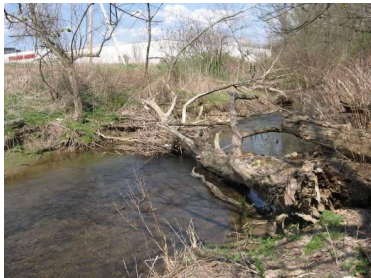
Trees that have fallen across the stream can create dams and present a flooding hazard.

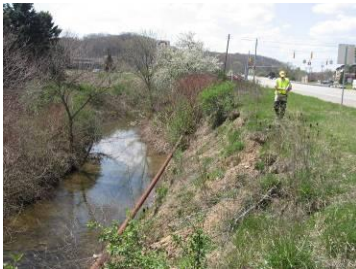
MP3 along McKnight Road has several pipes that are at severe risk of collapse as the streambank has eroded away, leaving them suspended and without support.

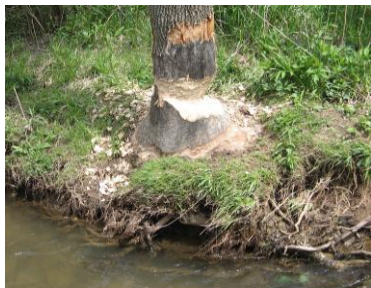
The impact of beaver activity as a contribution to flooding along MP3 should be studied.

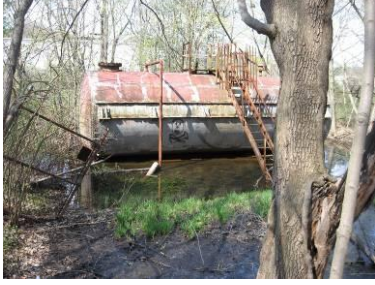
An inactive storage tank near the stream presents a significant hazard of stream contamination or damage to vegetation or structures if dislodged and floated downstream.

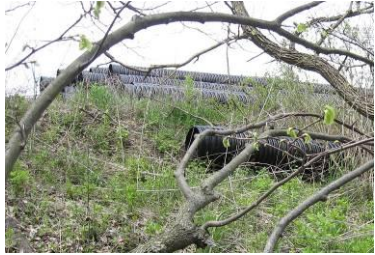
Improper streamside storage, for example this drainage pipe that has rolled over the hill, could create a dam during a high water event. Extreme high water could carry away the entire pile of pipes.

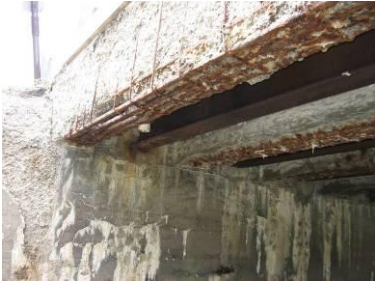
The decaying infrastructure of bridges such as this one on MP3 impacts stream quality and increases the risk of the structure failing in a high flow event.

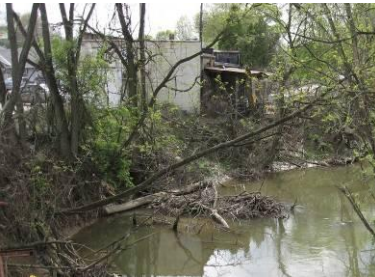
Development close to the stream channel has decreased flood zone capacity and promotes increased flood damage to property.

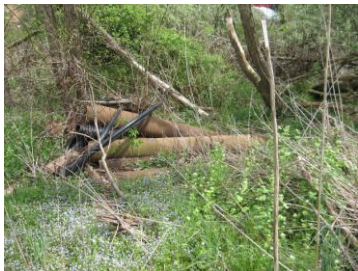
Improper disposal of materials in several places creates potential hazards if large items such as these pipes are swept downstream during a high flow event.

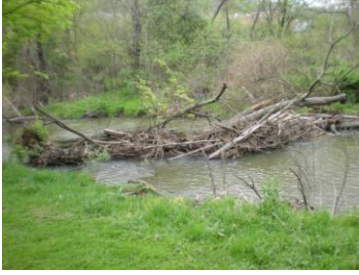
Trees brought down by bank erosion create traps for smaller debris and ultimately create debris jams and enhanced opportunities for localized flooding.

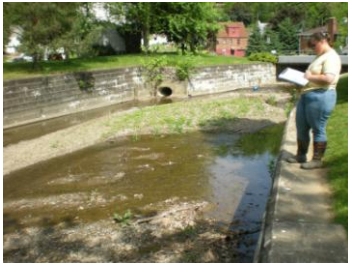
Sedimentation of channelized portions of main Pine Creek and its tributaries reduces their capacity during high flow events.

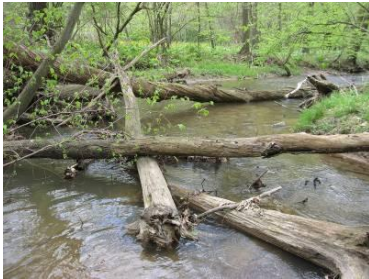
There are several debris jams in different stages of development. This is one in the early stages.

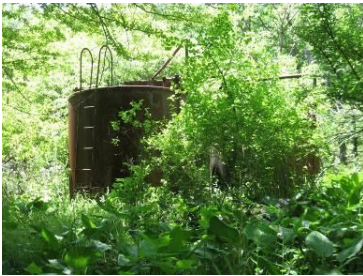
Three abandoned oil tanks were found with evidence of oil leakage.

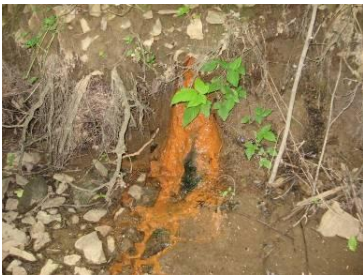
Small amount of orange seepage resembling AMD was seen draining from a pipe near a cleared, stone paved area.

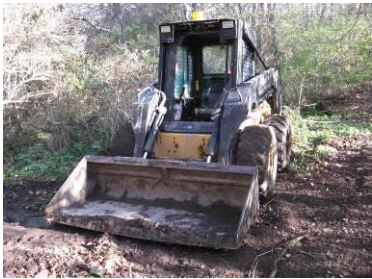
Protection of headwater portions of the watershed are critical because that is where large percentages of rain water infiltration occurs. Disruption of the riparian edges in upstream areas as seen by this Bobcat contributes large amounts of sediment to downstream reaches and reduces infiltration.

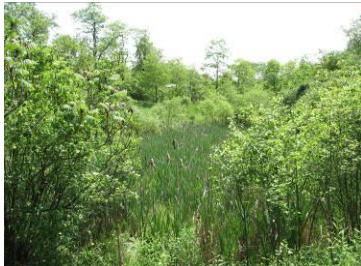
A wetland was identified near the confluence of Crouse Run with Pine Creek stream. This area can absorb large volumes of rain water.

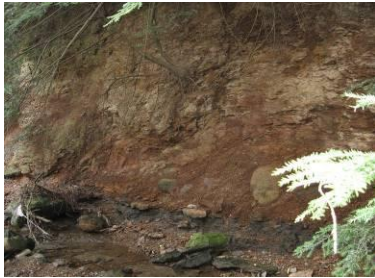
Severe erosion near the mouth of Harts Run on the south side of the stream puts a large hillside at risk.

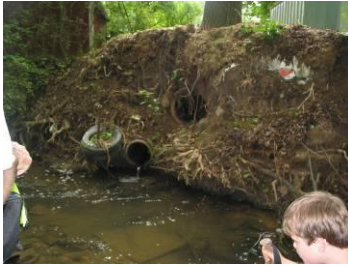
The most common issue observed on West Little Pine is streambank erosion in various forms. Here the erosion threatens businesses and a large tree that could block the channel if it falls.

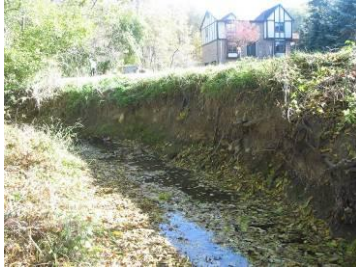
Erosion is impacting residential properties, in this case as it is decreasing the size of a residential yard.

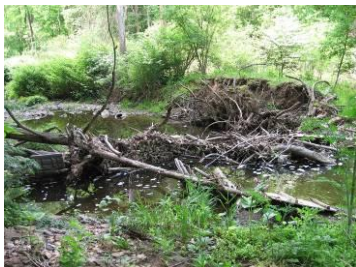
As elsewhere, debris from fallen trees presents a real hazard to streambank stability as water deflected by the debris seeks an alternate route, here eroding the far bank.

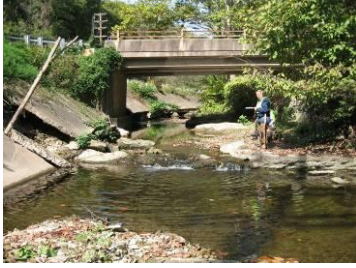
Even the most sturdy bank armoring designs have proven unequal to the force of West little Pine in its southern reaches. Here, a road is in jeopardy if the wall fails.

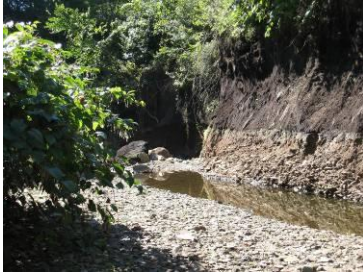
Soil types directly impact erodibility of streambanks. Here, an old fill pile, perhaps of ash from historical steel plants nearby has eroded into a high wall.

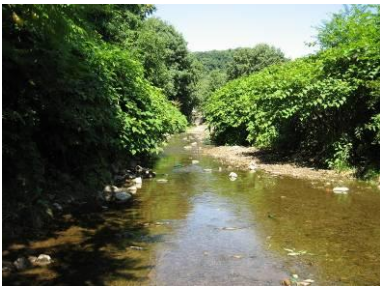
West Little Pine hosts an enormous amount of Japanese Knotweed, the invasive exotic plant that shades out native bushes that provide critical nutrient base to a healthy stream ecosystem.
