**PINE CREEK WATERSHED  
CHANNEL and RIPARIAN ASSESSMENT  
and  
RESTORATION PLAN**

**NORTH AREA ENVIRONMENTAL COUNCIL**  
in partnership with the  
**PINE CREEK WATERSHED COALITION**

**ALLEGHENY COUNTY, PENNSYLVANIA**

**March 2010**

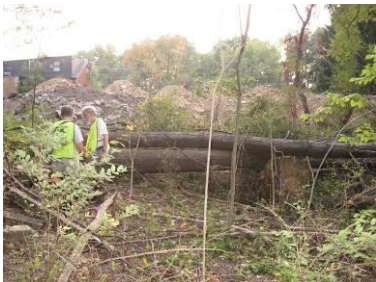
Fill piles without erosion control to prevent erosion can impact stream life and channel capacity.

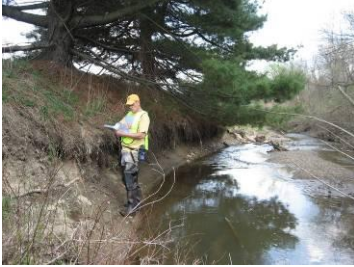
There are a number of erosion undercuts threatening substantial trees that are holding the streambank. These trees could block the channel if they fell into the stream.

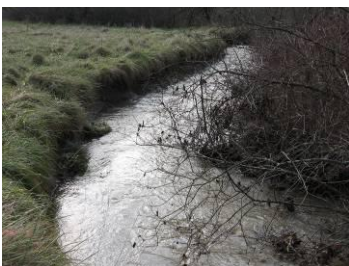
This site in North Park is part of a wetland mitigation project underway by the PA Turnpike Commission in which 5 acres are being restored to their original wetland configuration.

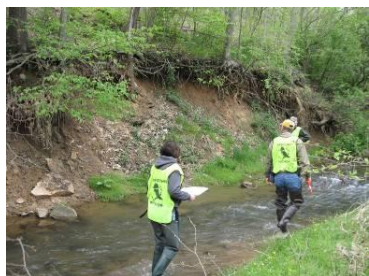
Erosion and tree undercutting just off S. Montour Rd.

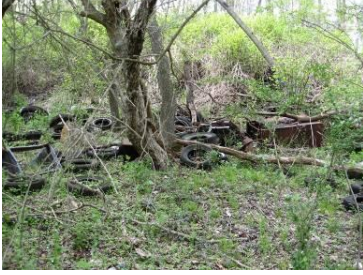
Several sights had old deposits of machinery, or debris. This is a large tire dump with assorted appliance pieces.

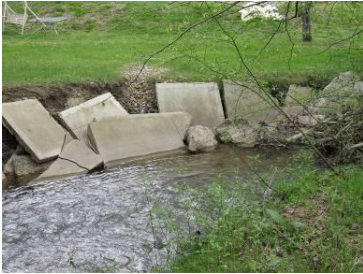
Efforts to armor stream bank with concrete slab are not completely effective.

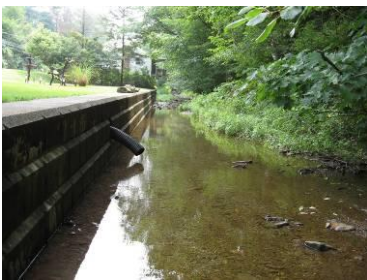
Retaining walls increase erosion of flowing water in high flow events by narrowing channel

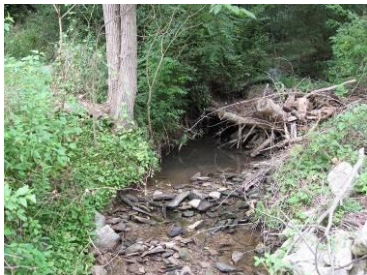
Debris can be caught against culverts in high flow event, creating dams.

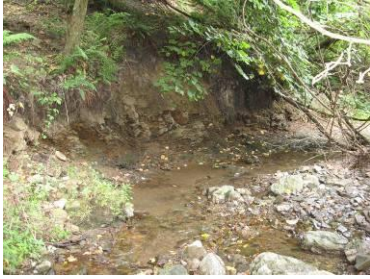
The constricted channel contributes to erosion of steep banks.

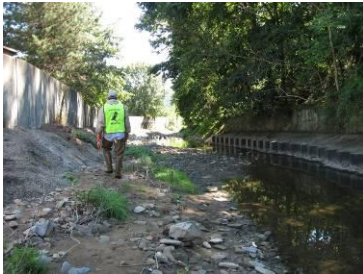
The lower reaches of West Little Pine have received large volumes of sediment from the upper portions of the watershed during storm events. In some areas the deposits have become problematic because they reduce the capacity of the constricted channel during high flow events.
